Project SS 2006
 Linda Cavasin, Daniela Michel,
 Mara De Zanet, Melanie Hubacher

Non-destructive testing of concrete elements and investigation of the data using statistical methods

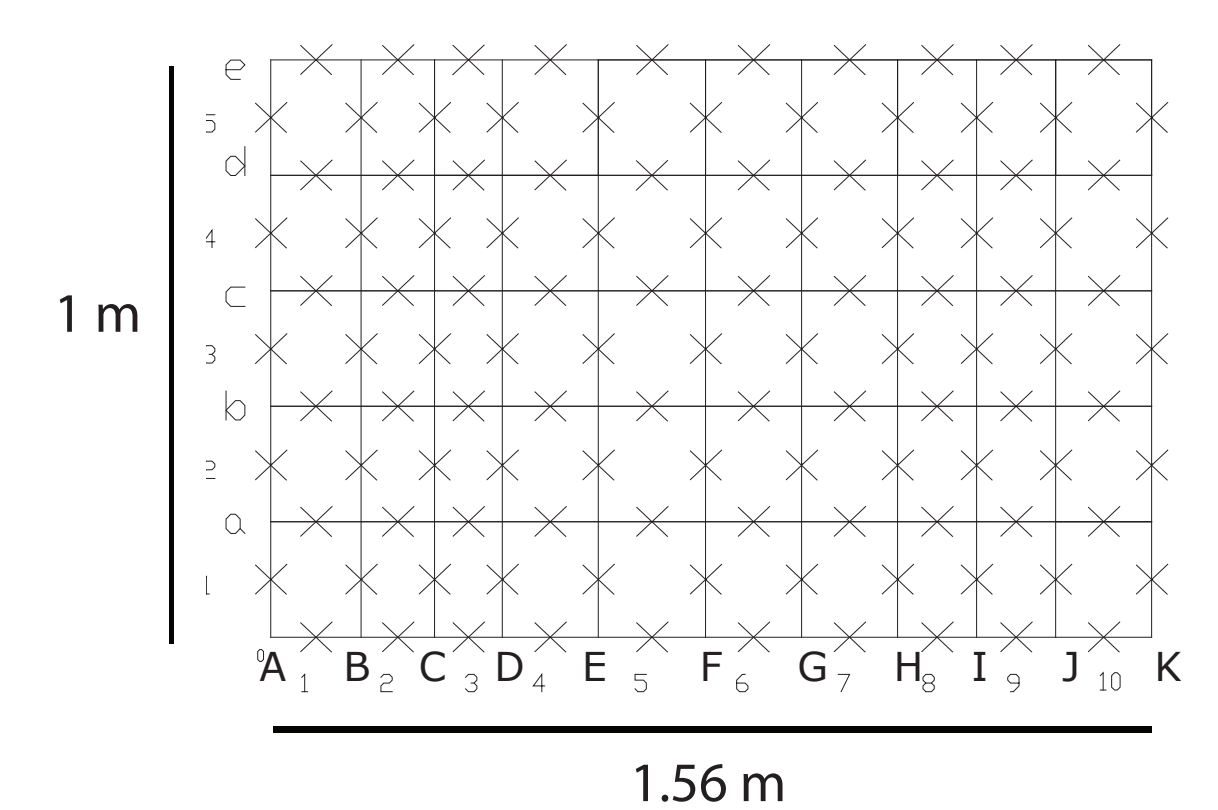
Sketch of the concrete cover beam

First of all we detected the reinforcement rebars with the Profometer and drew the pattern on the concrete beam. Then we have chosen 105 locations on the rebars to take measurements. For all tests we used the same points.

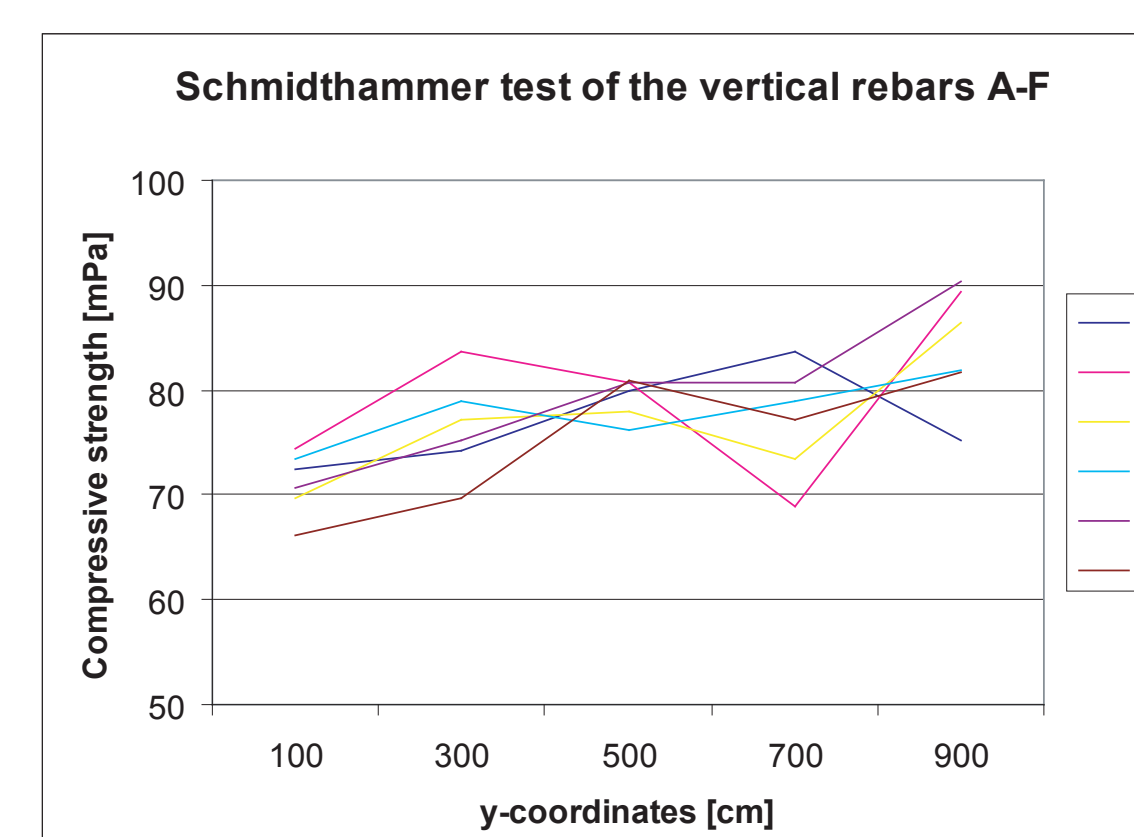
Part of Schmidthammer results

Schmidt Hammer is a test used to measure the surface hardness and composition of the concrete. The results from the Schmidthammer test were quite satisfying because there are very little variations of the compressive strength. The diagram on the left, a plot of some vertical rebars, shows this very well. The measured values lie between 59 and 91 N/mm, but most of them are seen in the interval from 70 to 81, a sign of a very high compressive strength.

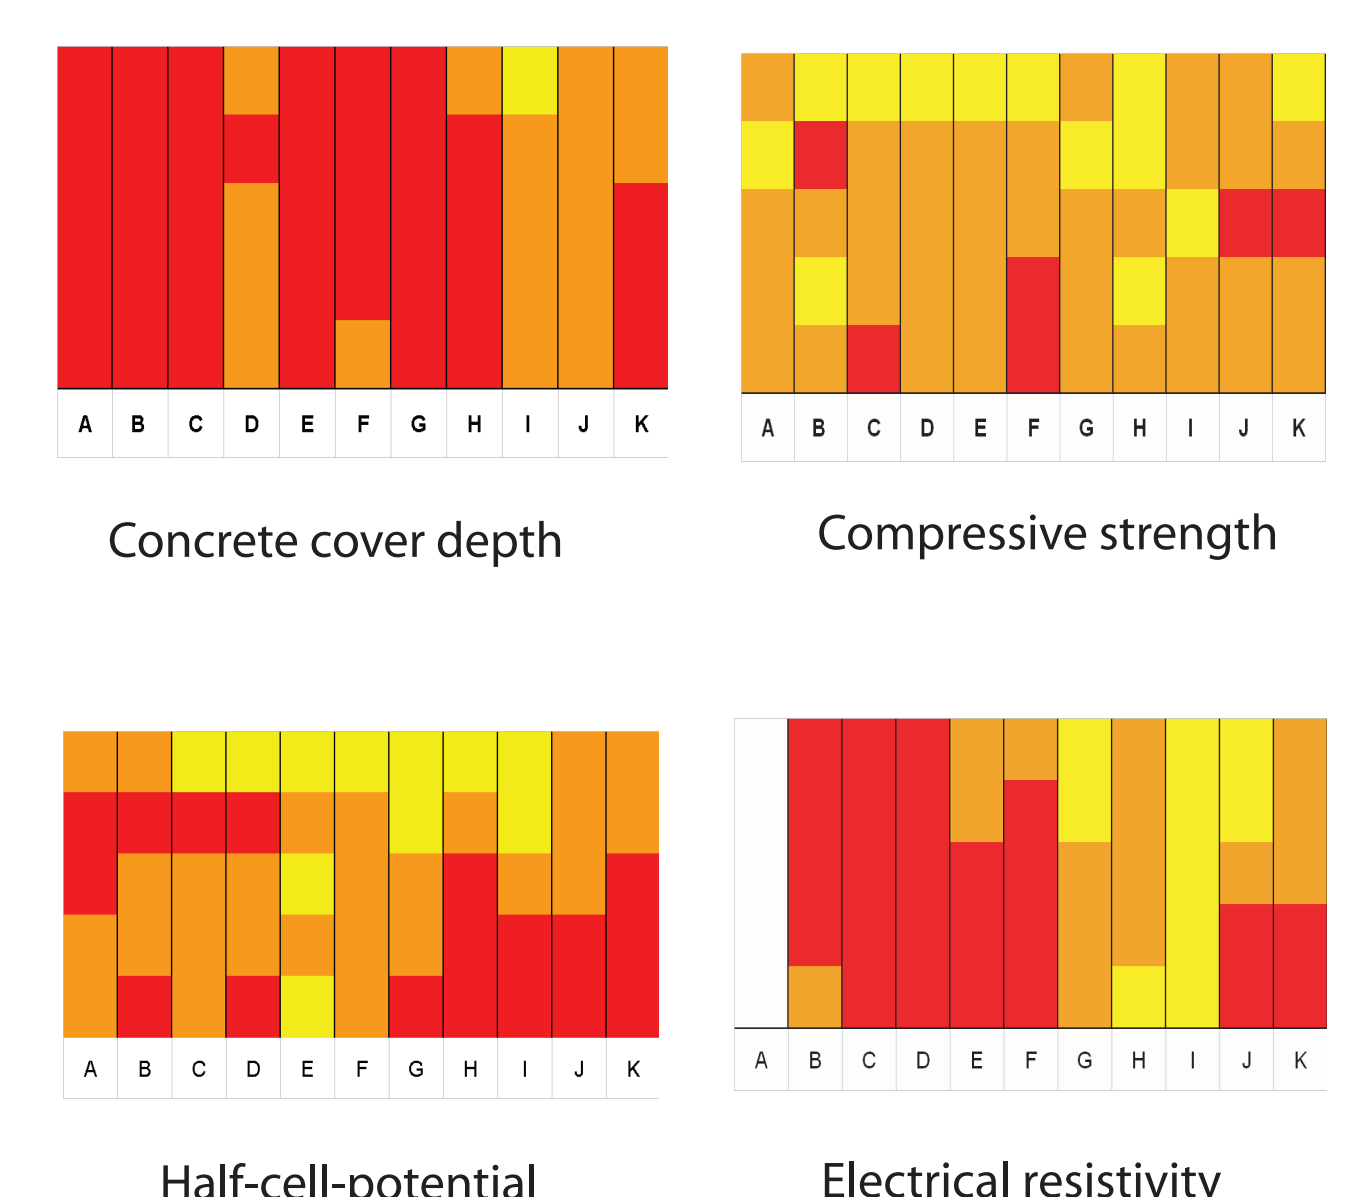
Colour maps

To compare the test results the colour maps allow the identification of the different areas of the concrete beam. Even if some of them show more similarities than others, they all indicate more or less the same areas with corrosion risk. Considering all the colour maps it can be seen that the most endangered area is located in the lower left part of the beam and that in the upper part and on the right the risk of corrosion is not that high.

higher risk
 lower risk

Nearly all of the data/values from the tests indicate no or very low corrosion risk. Only in the electrical resistivity test is shown a higher risk for some areas, but they are not really problematic either. Still it is important to remember that the environmental conditions changed for the different testing days. There were days with rain, wind and low temperature (concrete cover) while on the opposite the electrical resistivity and the half-cell-potential were done on a hot, dry and sunny day. This should also be considered when evaluating the results, especially for the last two mentioned tests, as they depend very much on the humidity of the concrete. Taking into account all results, we come to the conclusion that the concrete beam is not specially endangered to corrosion. Nevertheless, it is better to keep an eye on the red areas of our colour maps, as in the future, they may be potential areas for corrosion.
